Heaton Primary Accessibility Action Plan April 2023

4.1 - ACTION TABLE

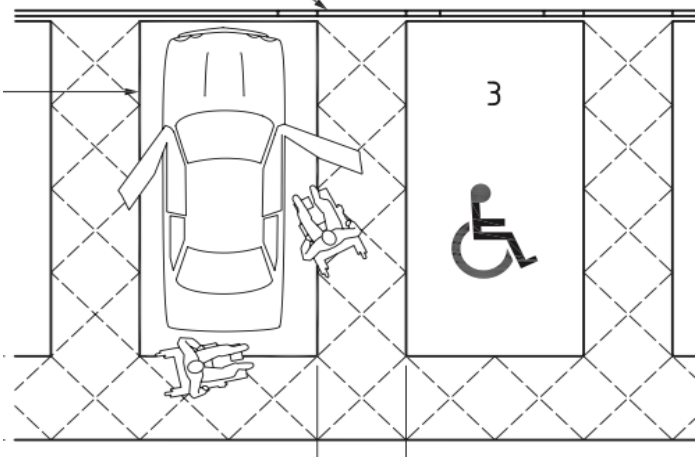
Item Ref.	Details / Issue	Recommendation	Est Cost	Action Taken
PRI OR I TY A				
2.3	The position of the bays would not allow both bays to be used at the same time.	<p>The bays should be repositioned, parallel to one another, to allow both bays to be accessed at all times.</p> <p>The designated accessible parking should be clearly marked out at least 2.4m wide x 4.8m long plus a 1.2m side transfer zone at the side and end of the bay.</p>

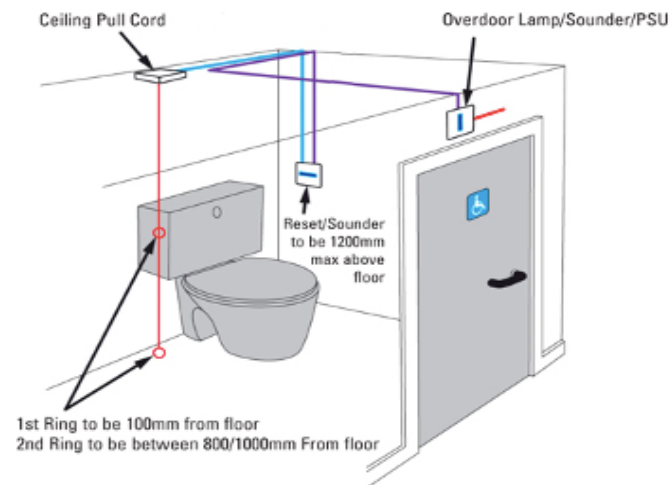
13.11

The cord alarm was marginally high from ground floor level in facility 270.

The years 5 and 6 facility featured a cord alarm that was tucked behind a pipe, high from ground floor level.

If a cord alarm is not within a suitable distance from ground floor level, a distress call may go unnoticed.

Implement a management procedure to ensure that cord alarms are always kept loose and not tied up.

According to BS8300 - An emergency assistance pull cord should be sited so that it can be operated from the WC and from an adjacent floor area. The emergency assistance pull cord, coloured red, should be provided with two red bangles of 50 mm diameter, one set at a height between 800 mm and 1000 mm and the other set at 100 mm above floor level.

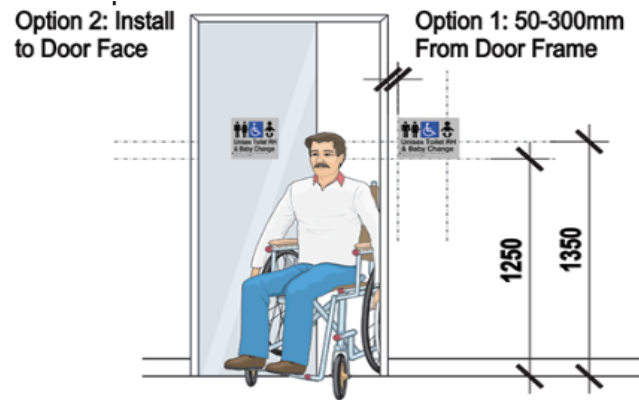
15.3

Some WC facilities were suitably signed with pictorial information.

The signage on facility 42 was slightly damaged.

The Hygiene Room 270 was not suitably signed for its purpose.

The WC facility 171 in years 5 and 6 was not suitably signposted.

The appropriate toilet signage should be provided. As well as signage on the toilet doors, there should also be signs indicating where the accessible WCs are located.

BS8300 states - Information and direction signs should be provided at each point where they are required, e.g. at junctions of circulation routes, at key locations such as doorways and reception points, at facilities such as telephones and toilets, and in rooms, spaces and counters. The colour, design and typeface of signs should be consistent throughout a building.

All accessible WC door signage should ideally be accessible to all disabled people with Braille and embossed lettering preferred.

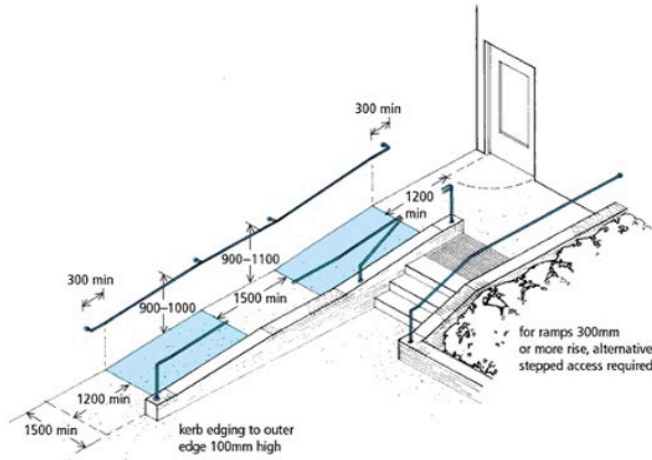
3.1

The ramps leading towards the key stage two playground, from both the key stage one and key stage two classrooms were long with no level landings. Contrast was not provided to these ramps to indicate a change in gradient.

The ramp should be subject to remedial works to reduce the gradient to a reasonable slope that can comply with BS8300 and ADM-2:1.26 requirements.

Any permanent ramp must be a maximum 1:12 over a maximum going of 2m, it should be a minimum 1.2m wide and feature 1.2m landings at head and foot, handrails to both sides and a contrasted sloped surface.

Colour contrast should be added to the surface of the ramps.

According to BS8300 - The surface of a ramp should contrast visually with the landings and the edge protection so that its presence is discernible by people who are blind or partially sighted.

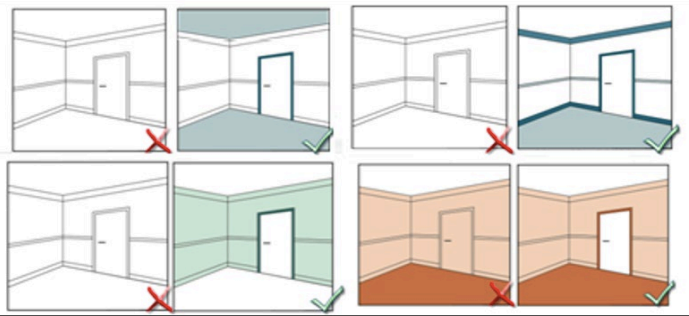
<p>7.4</p>	<p>Most areas of flooring had suitable junctions.</p> <p>A slightly damaged raised area of flooring was developing in room 223, which could become a trip hazard.</p>	<p>Any matting should either have its surface level with the adjacent floor finish or, if surface laid, be of a type that has a rubber backing and chamfered edges. Ideally surface mats should be securely fixed to the floor at their edges and at any joints, to avoid the risk of tripping or slipping and movement caused by heavier wheelchairs.</p>	<p>M</p>	
<p>8.1</p>	<p>Most internal doors were well contrasted against the surroundings.</p> <p>The fire exit doors across KS1 were not well contrasted against the surroundings frames.</p> <p>The exit door by area 21 was not well contrasted against the surrounding frame.</p> <p>Contrast could assist people who are partially sighted in locating the door.</p>	<p>Ideally all doors should have contrast against the surroundings upon which they are seen. This could be achieved by painting the door frames a contrasting colour. Adding colour contrast will aid people with impaired vision.</p>

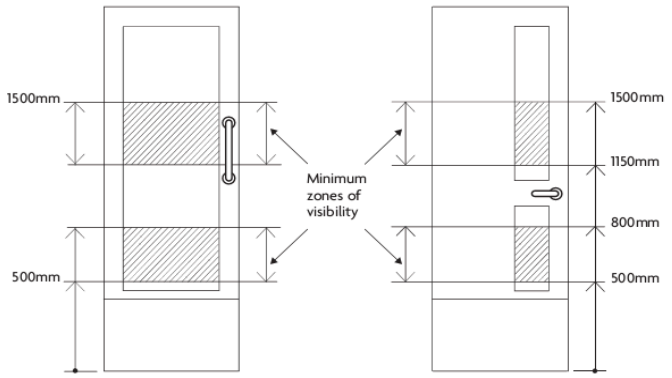
<p>8.3</p>	<p>Most areas of the school featured doors with suitable vision panels.</p> <p>The doors in zone 4 featured high vision panels, which could be a collision hazard for wheelchair users and people who are short in stature.</p>

<p>A rolling refurbishment programme should be implemented to install new BS8300 compliant doors with vision panels to zone 4.</p> <p>☒ Vision panels need to be included in frequently used doors where privacy (toilets etc.) is not required with a minimum visibility zone between 500mm and 1500mm from floor level and located at the side of the leading edge.</p> <p>☒ Glass should comply with BS6206.</p> <p>☒ It is recommended that site management implement a procedure to ensure that the temporary notices are not on the vision panels. This will prevent a potential collision hazard.</p>	<p>M</p>	
<p>8.4</p>	<p>Door and a half systems were used across many corridors within the school.</p> <p>Double doors into 212 may not provide a sufficient width when only one leaf is open.</p> <p>Double doors leading outside, by 197, were approximately 740mm.</p> <p>Double doors towards zone 5 may not provide sufficient width when only one leaf is open.</p> <p>Narrow double doors were identified into the area opposite unisex WC facilities in years 5 and 6, measuring to be approximately 500mm.</p>	<p>It would be beneficial for wheelchair users to convert the doors identified to door and a half systems. This would allow wheelchair users a greater clearance width when using the master leaf.</p> <p>☒ Refer to BS8300 - An effective clear width of less than 800 mm may result in people with poor manoeuvring ability or with large wheelchairs not being able to pass through without damage to themselves or the door. Use of the preferred effective clear width more easily accommodates people with assistance dogs and where there is heavy pedestrian traffic.</p>	<p>M</p>

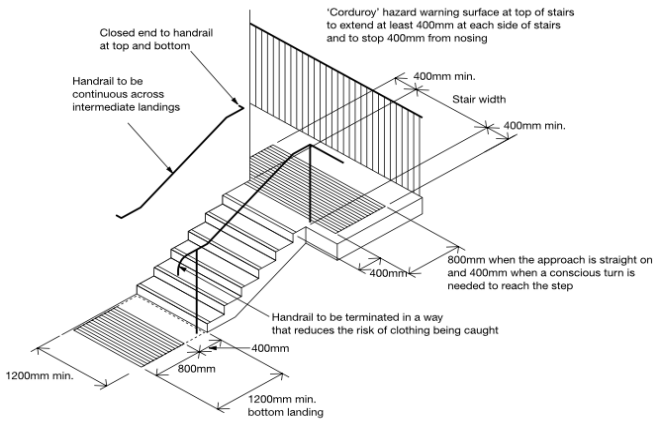
4.1

The steps leading towards the key stage two playground featured tactile paving.
 The steps near to room 161 and those leading near the main entrance, did not feature tactile paving to provide warning of the first and final step.

Install tactile paving to the top of the external steps throughout the site.
 BS8300 - To give advance warning of a step, tactile paving with a corduroy hazard warning surface should be provided at the top and bottom of each flight, excluding intermediate landings with continuous handrails. Where the approach to the stair is wider than the flight, the tactile surface should extend beyond the line of each edge of the flight.

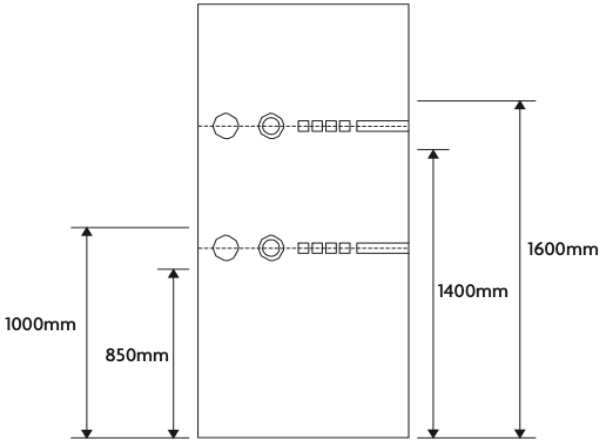
<p>5.9</p>	<p>Not applicable for the main entrance.</p> <p>The double doors leading into entrance near room 42 were glazed with no manifestations and could be a collision hazard.</p>

<p>Manifestation can take various forms, e.g. broken or solid lines, patterns or company logos</p>	<p>All full height glazed areas must be clearly highlighted with manifestation that contrasts visually with the surface behind it under both natural and artificial lighting conditions, from all likely viewing directions. This manifestation should be located within two zones, from 850mm to 1000mm from the floor and from 1400mm to 1600mm from the floor.</p>	<p>M</p>
