Heaton Primary Accessibility Action Plan April 2023

4.1 - ACTION TABLE

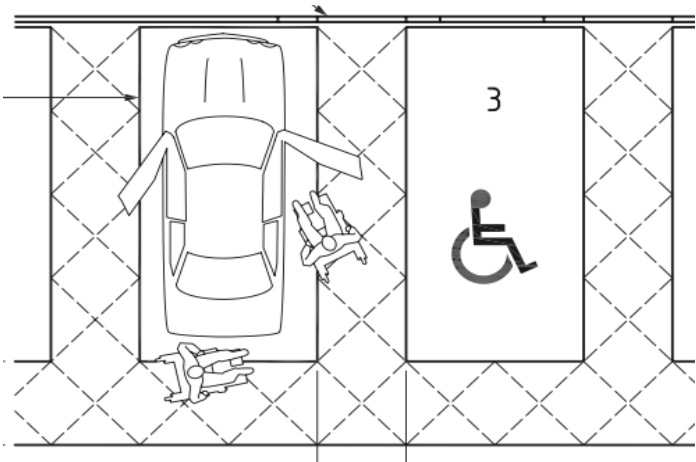
Item Ref.	Details / Issue	Recommendation	Est Cost	Action Taken
PRIORITY A				
2.3	The position of the bays would not allow both bays to be used at the same time.	<p>The bays should be repositioned, parallel to one another, to allow both bays to be accessed at all times.</p> <p>The designated accessible parking should be clearly marked out at least 2.4m wide x 4.8m long plus a 1.2m side transfer zone at the side and end of the bay.</p>

M	Only 1 bay is for parking other is for parent to drop off disabled child.

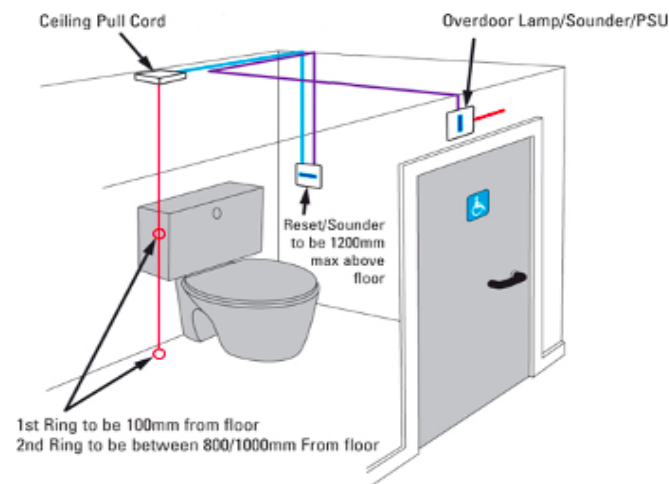
13.11

The cord alarm was marginally high from ground floor level in facility 270.

The years 5 and 6 facility featured a cord alarm that was tucked behind a pipe, high from ground floor level.

If a cord alarm is not within a suitable distance from ground floor level, a distress call may go unnoticed.

Implement a management procedure to ensure that cord alarms are always kept loose and not tied up.

Cord untied in Green base Toilet

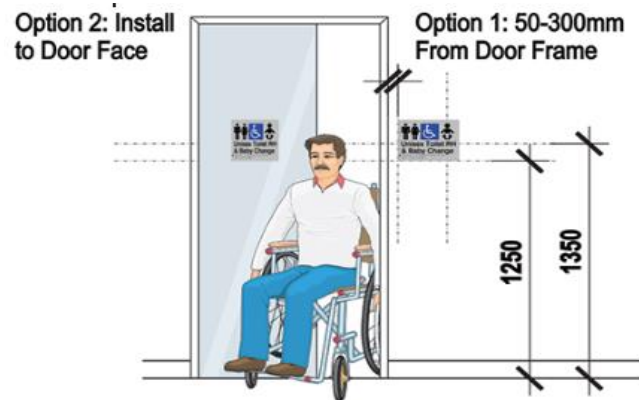
15.3

Some WC facilities were suitably signed with pictorial information.

The signage on facility 42 was slightly damaged.

The Hygiene Room 270 was not suitably signed for its purpose.

The WC facility 171 in years 5 and 6 was not suitably signposted.

The appropriate toilet signage should be provided. As well as signage on the toilet doors, there should also be signs indicating where the accessible WCs are located.

All accessible WC door signage should ideally be accessible to all disabled people with Braille and embossed lettering preferred.

Raised lettering / Braille Toilet signs added to 3 doors 263,270 & 171

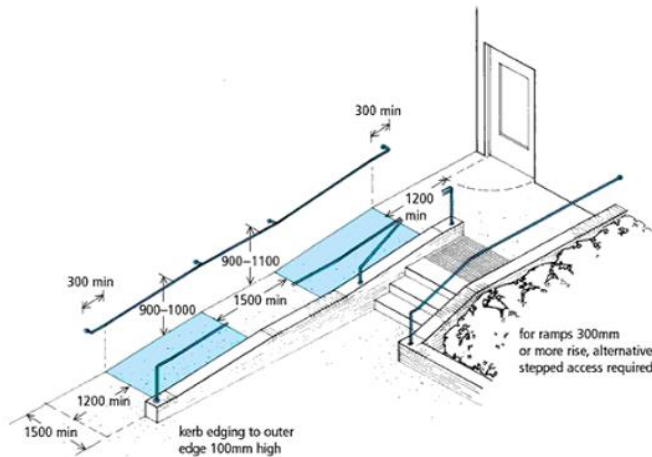
3.1

The ramps leading towards the key stage two playground, from both the key stage one and key stage two classrooms were long with no level landings. Contrast was not provided to these ramps to indicate a change in gradient.

The ramp should be subject to remedial works to reduce the gradient to a reasonable slope that can comply with BS8300 and ADM-2:1.26 requirements.

Any permanent ramp must be a maximum 1:12 over a maximum going of 2m, it should be a minimum 1.2m wide and feature 1.2m landings at head and foot, handrails to both sides and a contrasted sloped surface.

Colour contrast should be added to the surface of the ramps.

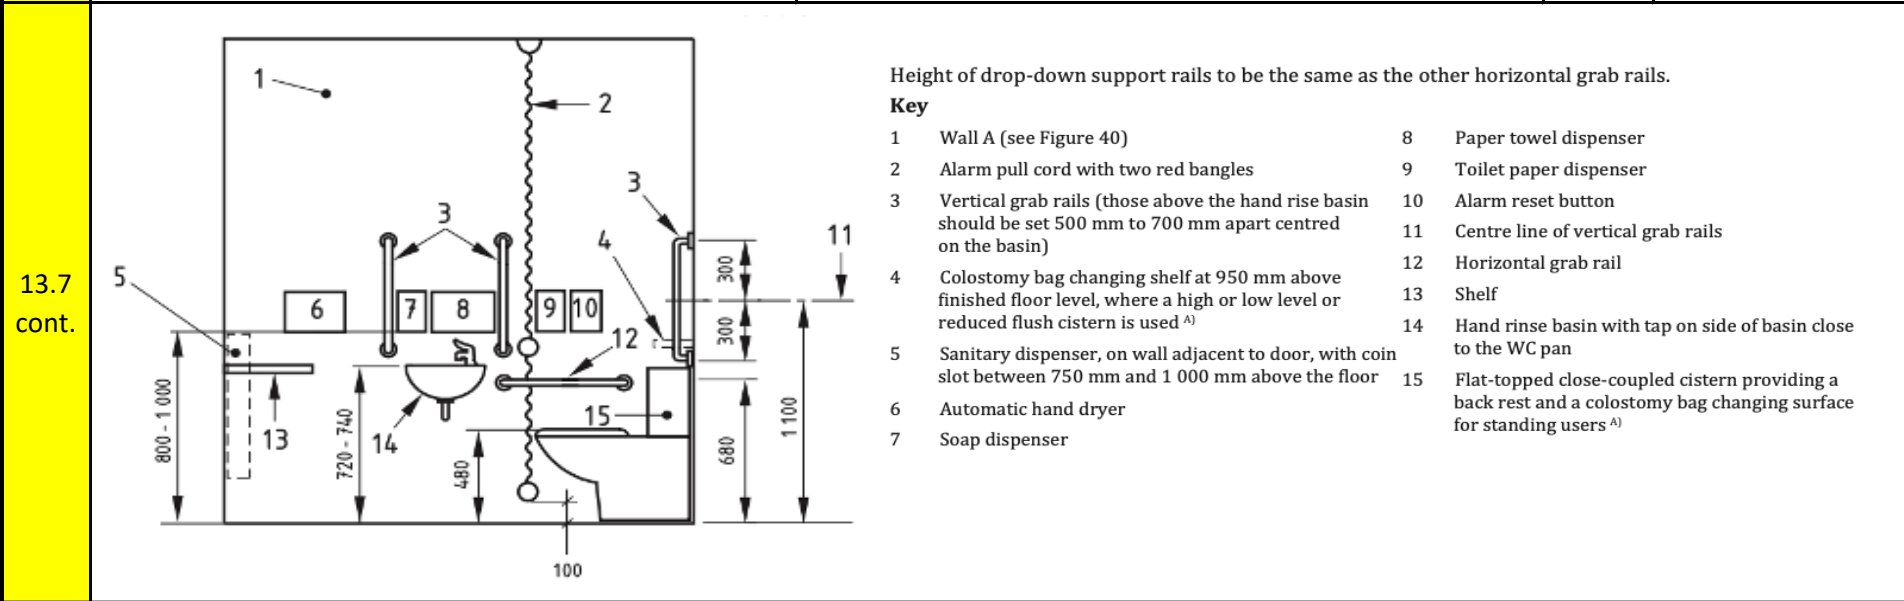
<p>13.7</p>	<p>Compartment 270 (the hygiene room) featured grab rails with minimal colour contrast, and a grab rail was missing to the left of the hand wash basin.</p> <p>A grab rail was missing to the left of the hand wash basin in the facility by years 5 and 6.</p> <p>The facility being refurbished featured grab rails that were not well contrasted to the top half.</p>	<p>The grab rail sets should be replaced with a new BS8300 compliant set that offers colour contrast. Alternatively, a contrasted background could be provided.</p> <p>A difference in LRV (Light Reflectance Value) between rail and background of 30 points is considered reasonable. In accessible WCs a blue rail set on white walls is a common accessible combination.</p> <p>Grab rails should be positioned as shown in BS8300 Figure 42:</p>	<p>M</p>	
-------------	--	---	----------	--

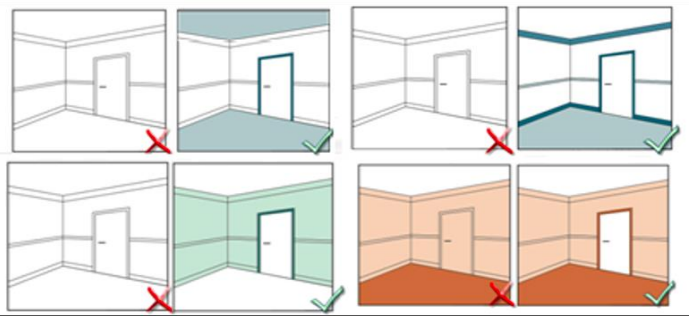
<p>7.4</p>	<p>Most areas of flooring had suitable junctions.</p> <p>A slightly damaged raised area of flooring was developing in room 223, which could become a trip hazard.</p>	<p>Any matting should either have its surface level with the adjacent floor finish or, if surface laid, be of a type that has a rubber backing and chamfered edges. Ideally surface mats should be securely fixed to the floor at their edges and at any joints, to avoid the risk of tripping or slipping and movement caused by heavier wheelchairs.</p>	<p>M</p>	<p>Repaired.</p>
<p>8.1</p>	<p>Most internal doors were well contrasted against the surroundings.</p> <p>The fire exit doors across KS1 were not well contrasted against the surroundings frames.</p> <p>The exit door by area 21 was not well contrasted against the surrounding frame.</p> <p>Contrast could assist people who are partially sighted in locating the door.</p>	<p>Ideally all doors should have contrast against the surroundings upon which they are seen. This could be achieved by painting the door frames a contrasting colour. Adding colour contrast will aid people with impaired vision.</p>

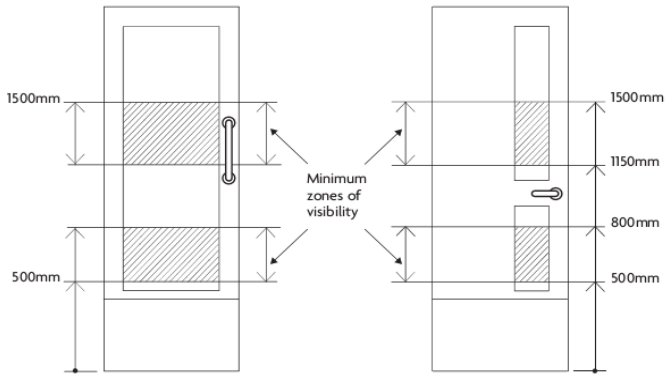
<p>8.3</p>	<p>Most areas of the school featured doors with suitable vision panels.</p> <p>The doors in zone 4 featured high vision panels, which could be a collision hazard for wheelchair users and people who are short in stature.</p>

<p>A rolling refurbishment programme should be implemented to install new BS8300 compliant doors with vision panels to zone 4.</p> <p>☒ Vision panels need to be included in frequently used doors where privacy (toilets etc.) is not required with a minimum visibility zone between 500mm and 1500mm from floor level and located at the side of the leading edge.</p> <p>☒ Glass should comply with BS6206.</p> <p>☒ It is recommended that site management implement a procedure to ensure that the temporary notices are not on the vision panels. This will prevent a potential collision hazard.</p>	<p>M</p>	
<p>8.4</p>	<p>Door and a half systems were used across many corridors within the school.</p> <p>Double doors into 212 may not provide a sufficient width when only one leaf is open.</p> <p>Double doors leading outside, by 197, were approximately 740mm.</p> <p>Double doors towards zone 5 may not provide sufficient width when only one leaf is open.</p> <p>Narrow double doors were identified into the area opposite unisex WC facilities in years 5 and 6, measuring to be approximately 500mm.</p>	<p>It would be beneficial for wheelchair users to convert the doors identified to door and a half systems. This would allow wheelchair users a greater clearance width when using the master leaf.</p> <p>☒ Refer to BS8300 - An effective clear width of less than 800 mm may result in people with poor manoeuvring ability or with large wheelchairs not being able to pass through without damage to themselves or the door. Use of the preferred effective clear width more easily accommodates people with assistance dogs and where there is heavy pedestrian traffic.</p>	<p>M</p>

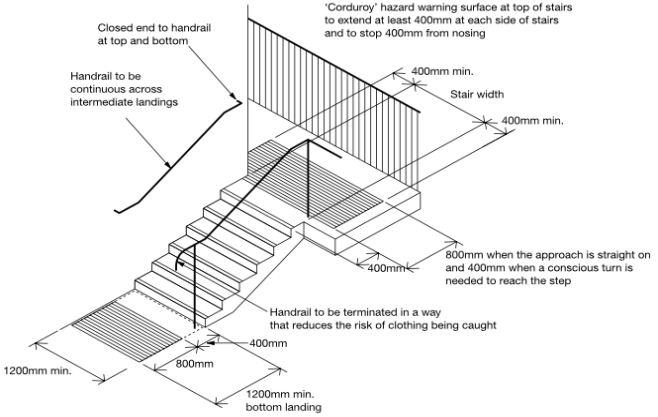
<p>2.7</p>	<p>Minimal lighting was identified in the car park. Are all bays adequately lit during darker hours?</p>	<p>Site management to undertake investigation of the lighting levels within the car parking areas during darker hours to ensure that they are sufficient.</p>	<p>N</p>	<p>Lighting acceptable in main car park, floodlights, school carpark lit by extrnal wall lighting.</p>
<p>4.1</p>	<p>The steps leading towards the key stage two playground featured tactile paving.</p> <p>The steps near to room 161 and those leading near the main entrance, did not feature tactile paving to provide warning of the first and final step.</p>

<p>Install tactile paving to the top of the external steps throughout the site.</p> <p>BS8300 - To give advance warning of a step, tactile paving with a corduroy hazard warning surface should be provided at the top and bottom of each flight, excluding intermediate landings with continuous handrails. Where the approach to the stair is wider than the flight, the tactile surface should extend beyond the line of each edge of the flight.</p>	<p>M</p>

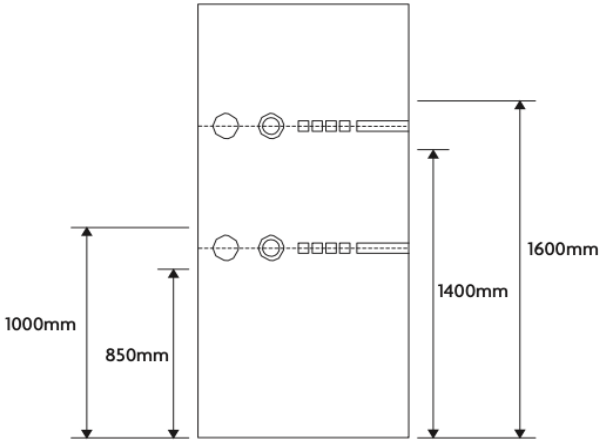
<p>5.9</p>	<p>Not applicable for the main entrance.</p> <p>The double doors leading into entrance near room 42 were glazed with no manifestations and could be a collision hazard.</p>

<p>1000mm 850mm 1600mm 1400mm</p> <p>Manifestation can take various forms, e.g. broken or solid lines, patterns or company logos</p>	<p>All full height glazed areas must be clearly highlighted with manifestation that contrasts visually with the surface behind it under both natural and artificial lighting conditions, from all likely viewing directions. This manifestation should be located within two zones, from 850mm to 1000mm from the floor and from 1400mm to 1600mm from the floor.</p>	<p>M</p>
