Heaton Primary Accessibility Action Plan

4.1 Action Table						
COSTS – N = NONE		M= MINIMAL	OG = ONGOING MAINTENANCE	ST = STRUCTURAL CHANGE	EX = MAJOR STRUCTUARL CHANGE	
Item Ref.	Details/Issue	Recommendation			Est Cost	Action Taken
PRIORITY A						
2.3	The position of the bays would not allow both bays to be used at the same time	<p>The bays should be repositioned, parallel to one another, to allow both bays to be accessed at all times .</p> <p>The designated accessible parking should be clearly marked out at least 2.4m wide x 4.8m long, plus a side transfer zone at the side and end of the bay.</p>

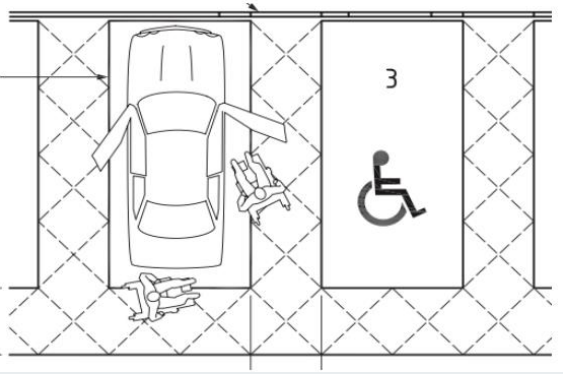
M	Only 1 bay is for parking, other is for parent to drop off disabled child.

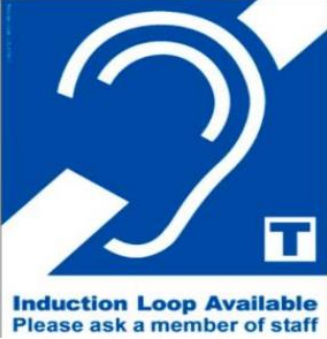
6.5	<p>An induction loop system was not identified at the reception area, which could assist people who have hearing loss.</p>

<p>The sign is blue with a white ear icon and a white 'T' in a square. Below the icon, it reads 'Induction Loop Available' and 'Please ask a member of staff'.</p>	<p>Install an induction loop to the reception desk. Install signage indicating the availability of the facility and ensure that staff members are aware of how to use the system.</p> <p>Direct Access has its own bespoke desk induction loop for people with hearing impairments. We are able to supply, install and provide brief training. Please see here and contact us for more information - https://directaccessgp.co.uk/induction-loops-andhearing-enhancement-systems/</p> <p>BS8300 - A hearing enhancement system, using induction loop, infrared or radio transmission, should be installed at service or reception counters where the background noise level is high.</p>	M	Portable system available

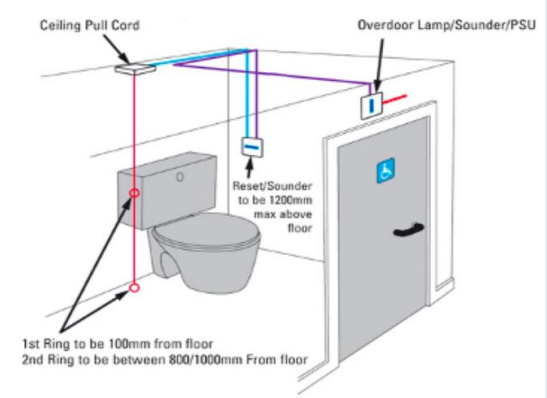
13.11	<p>The cord alarm was marginally high from ground floor level in facility 270.</p> <p>The years 5 and 6 facility featured a cord alarm that was tucked behind a pipe, high from ground floor level.</p> <p>If a cord alarm is not within a suitable distance from ground floor level, a distress call may go unnoticed.</p>	<p>Implement a management procedure to ensure that cord alarms are always kept loose and not tied up.</p> <p>According to BS8300 - An emergency assistance pull cord should be sited so that it can be operated from the WC and from an adjacent floor area. The emergency assistance pull cord, coloured red, should be provided with two red bangles of 50 mm diameter, one set at a height between 800 mm and 1000 mm and the other set at 100 mm above floor level.</p>	N	Cord untied in the Green Base Toilet

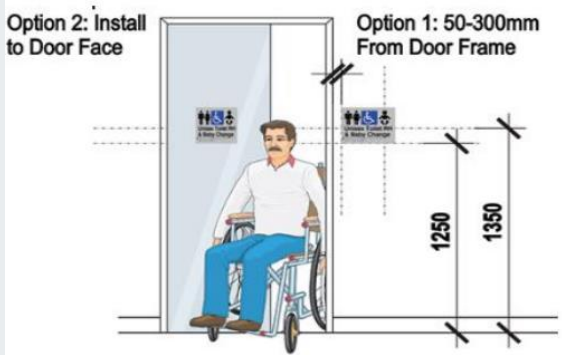
<p>15.3</p>	<p>Some WC facilities were suitably signed with pictorial information.</p> <p>The signage on facility 42 was slightly damaged.</p> <p>The Hygiene Room 270 was not suitably signed for its purpose.</p> <p>The WC facility 171 in years 5 and 6 was not suitably signposted.</p>

<p>The appropriate toilet signage should be provided. As well as signage on the toilet doors, there should also be signs indicating where the accessible WCs are located.</p> <p>BS8300 states - Information and direction signs should be provided at each point where they are required, e.g. at junctions of circulation routes, at key locations such as doorways and reception points, at facilities such as telephones and toilets, and in rooms, spaces and counters. The colour, design and typeface of signs should be consistent throughout a building.</p> <p>All accessible WC door signage should ideally be accessible to all disabled people with Braille and embossed lettering preferred.</p>

<p>M</p>	<p>Raised lettering / Braille Toilet signs added to 3 doors 263, 270 & 171</p>

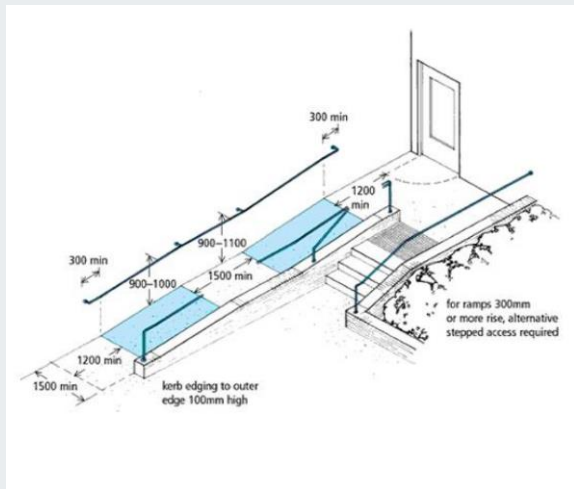
3.1 The ramps leading towards the key stage two playground, from both the key stage one and key stage two classrooms were long with no level landings. Contrast was not provided to these ramps to indicate a change in gradient.

The ramp should be subject to remedial works to reduce the gradient to a reasonable slope that can comply with BS8300 and ADM-2:1.26 requirements.

Any permanent ramp must be a maximum 1:12 over a maximum going of 2m, it should be a minimum 1.2m wide and feature 1.2m landings at head and foot, handrails to both sides and a contrasted sloped surface.

Colour contrast should be added to the surface of the ramps.

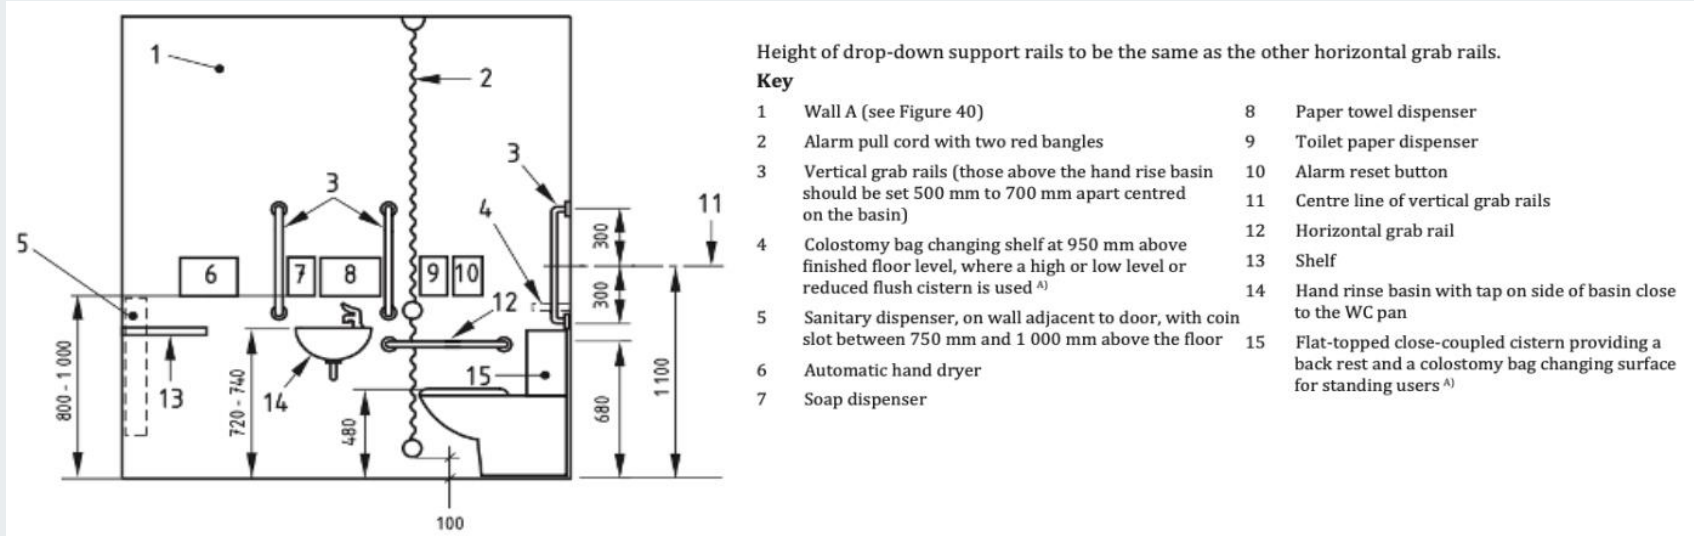
13.7
cont.

13.7	<p>Compartment 270 (the hygiene room) featured grab rails with minimal colour contrast, and a grab rail was missing to the left of the hand wash basin.</p> <p>A grab rail was missing to the left of the hand wash basin in the facility by years 5 and 6.</p> <p>The facility being refurbished featured grab rails that were not well contrasted to the top half.</p>	<p>The grab rail sets should be replaced with a new BS8300 compliant set that offers colour contrast. Alternatively, a contrasted background could be provided.</p> <p>A difference in LRV (Light Reflectance Value) between rail and background of 30 points is considered reasonable. In accessible WCs a blue rail set on white walls is a common accessible combination.</p> <p>Grab rails should be positioned as shown in BS8300 Figure 42:</p>	M

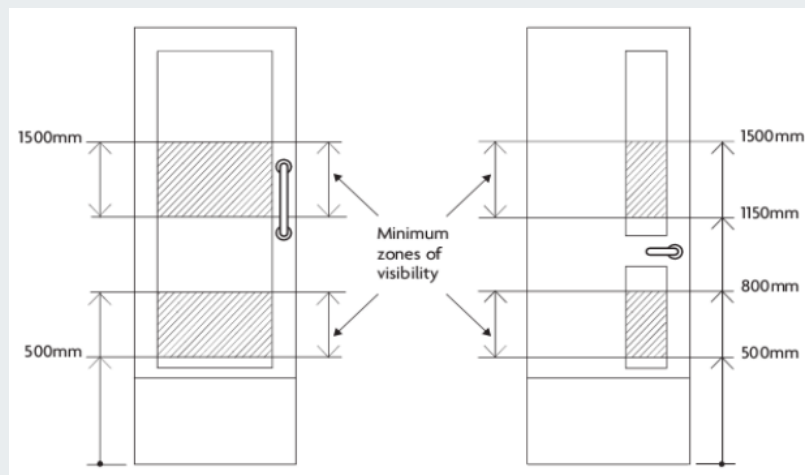
8.3 Most areas of the school featured doors with suitable vision panels. The doors in zone 4 featured high vision panels, which could be a collision hazard for wheelchair users and people who are short in stature.

A rolling refurbishment programme should be implemented to install new BS8300 compliant doors with vision panels to zone 4.

Vision panels need to be included in frequently used doors where privacy (toilets etc.) is not required with a minimum visibility zone between 500mm and 1500mm from floor level and located at the side of the leading edge.

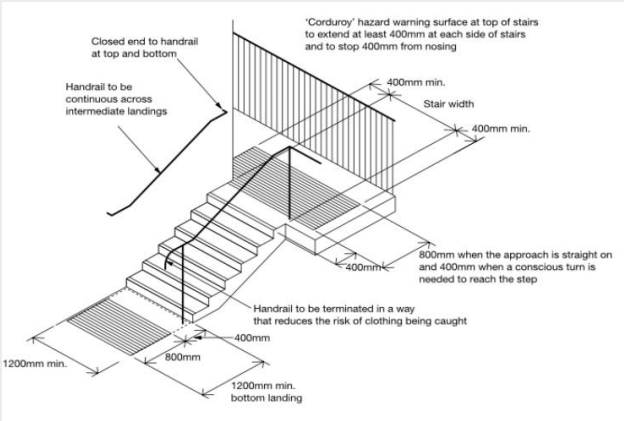
<p>4.1</p>	<p>The steps leading towards the key stage two playground featured tactile paving.</p> <p>The steps near to room 161 and those leading near the main entrance, did not feature tactile paving to provide warning of the first and final step.</p>

<p>Install tactile paving to the top of the external steps throughout the site.</p> <p>BS8300 - To give advance warning of a step, tactile paving with a corduroy hazard warning surface should be provided at the top and bottom of each flight, excluding intermediate landings with continuous handrails. Where the approach to the stair is wider than the flight, the tactile surface should extend beyond the line of each edge of the flight.</p>	<p>M</p>	
<p>4.3</p>	<p>Are all external steps adequately lit during darker hours?</p>	<p>Site management should undertake a review of the step lighting levels during darker hours to ensure that the step treads are evenly lit.</p> <p>Lighting on external steps and ramps should achieve a minimum level of 100 lux where they are external and adjacent to entrances/exits of buildings.</p>	<p>N</p>

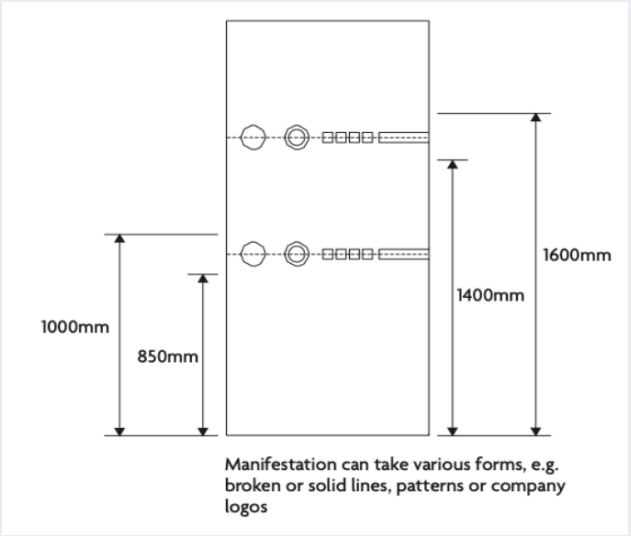
<p>5.9</p>	<p>Not applicable for the main entrance.</p> <p>The double doors leading into entrance near room 42 were glazed with no manifestations and could be a collision hazard.</p>

<p>1000mm 850mm 1400mm 1600mm</p> <p>Manifestation can take various forms, e.g. broken or solid lines, patterns or company logos</p>	<p>All full height glazed areas must be clearly highlighted with manifestation that contrasts visually with the surface behind it under both natural and artificial lighting conditions, from all likely viewing directions. This manifestation should be located within two zones, from 850mm to 1000mm from the floor and from 1400mm to 1600mm from the floor.</p>	<p>M</p>	
<p>5.11</p>	<p>An automated door was not provided to this site but may be beneficial should future budgets permit.</p>	<p>Powered doors may increase accessibility for a range of users and should be considered during any future developments.</p> <p>Power-operated pedestrian doors for installation in existing and new construction should be one of the following two types:</p> <p>a) a manually activated door controlled by a push pad, coded entry system, card swipe or remote control device; or b) an automatically activated door controlled, for example, by a motion sensor or a hands-free proximity reader. the provision and installation of power-operated doors should be in accordance with BS 7036-1.</p>	<p>M</p>
