Heaton Primary Accessibility Action Plan April 2023

4.1 - ACTION TABLE

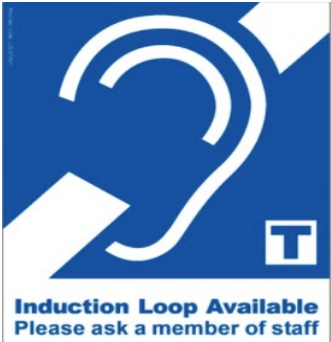
<p>6.5</p>	<p>An induction loop system was not identified at the reception area, which could assist people who have hearing loss.</p>

<p>The image shows a blue square sign with a white ear icon and a white induction loop symbol. Below the icon, the text reads "Induction Loop Available" and "Please ask a member of staff". There is also a small white 'T' in a blue square in the bottom right corner of the sign.</p>	<p>Install an induction loop to the reception desk. Install signage indicating the availability of the facility and ensure that staff members are aware of how to use the system.</p> <p>Direct Access has its own bespoke desk induction loop for people with hearing impairments. We are able to supply, install and provide brief training. Please see here and contact us for more information - https://directaccessgp.co.uk/induction-loops-and-hearingenhancement-systems/</p> <p>BS8300 - A hearing enhancement system, using induction loop, infrared or radio transmission, should be installed at service or reception counters where the background noise level is high.</p>	<p>M</p>

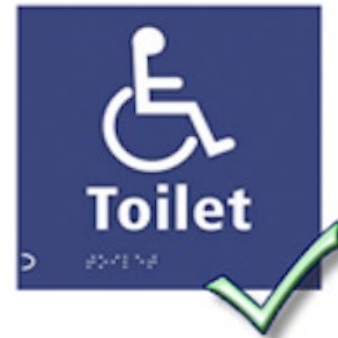
The signage on facility 42 was slightly damaged.

BS8300 states - Information and direction signs should be provided at each point where they are required, e.g. at junctions of circulation routes, at key locations such as doorways and reception points, at facilities such as telephones and toilets, and in rooms, spaces and counters. The colour, design and typeface of signs should be consistent throughout a building.

All accessible WC door signage should ideally be accessible to all disabled people with Braille and embossed lettering preferred.

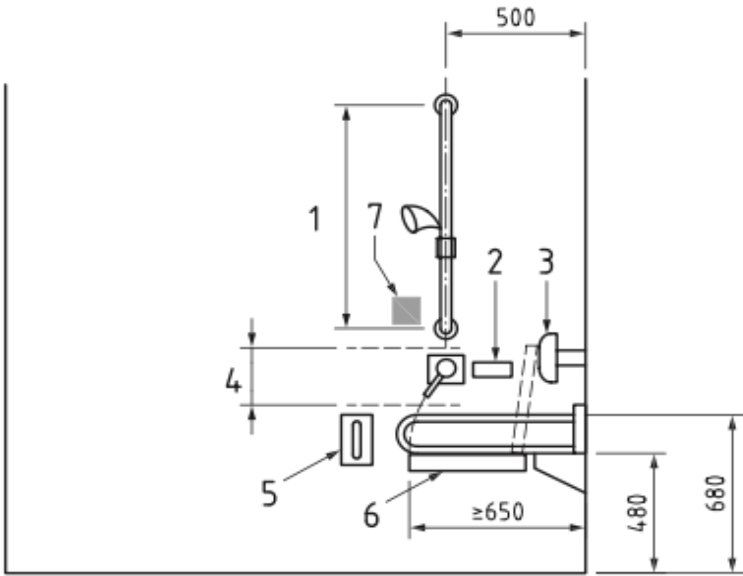
<p>12.8</p>	<p>A level access shower was identified in Hygiene Room 270. This facility did not feature a drop-down chair or contrasted grab rails. A hoist system was also provided to this facility.</p> <p>The student coat storing areas did not feature areas with lowered coat hooks, which could assist people who are short in stature.</p>	<p>A padded tip-up seat should be securely fixed to the wall and drop-down support rails and grab rails for a self-contained shower/ changing area should be located as shown in Figure 37.</p> <p>It may be beneficial to provide clothes hooks at two heights, one level at 1050mm and the other at 1400mm above the floor.</p>	<p>M</p>	
<p>12.8 cont.</p>

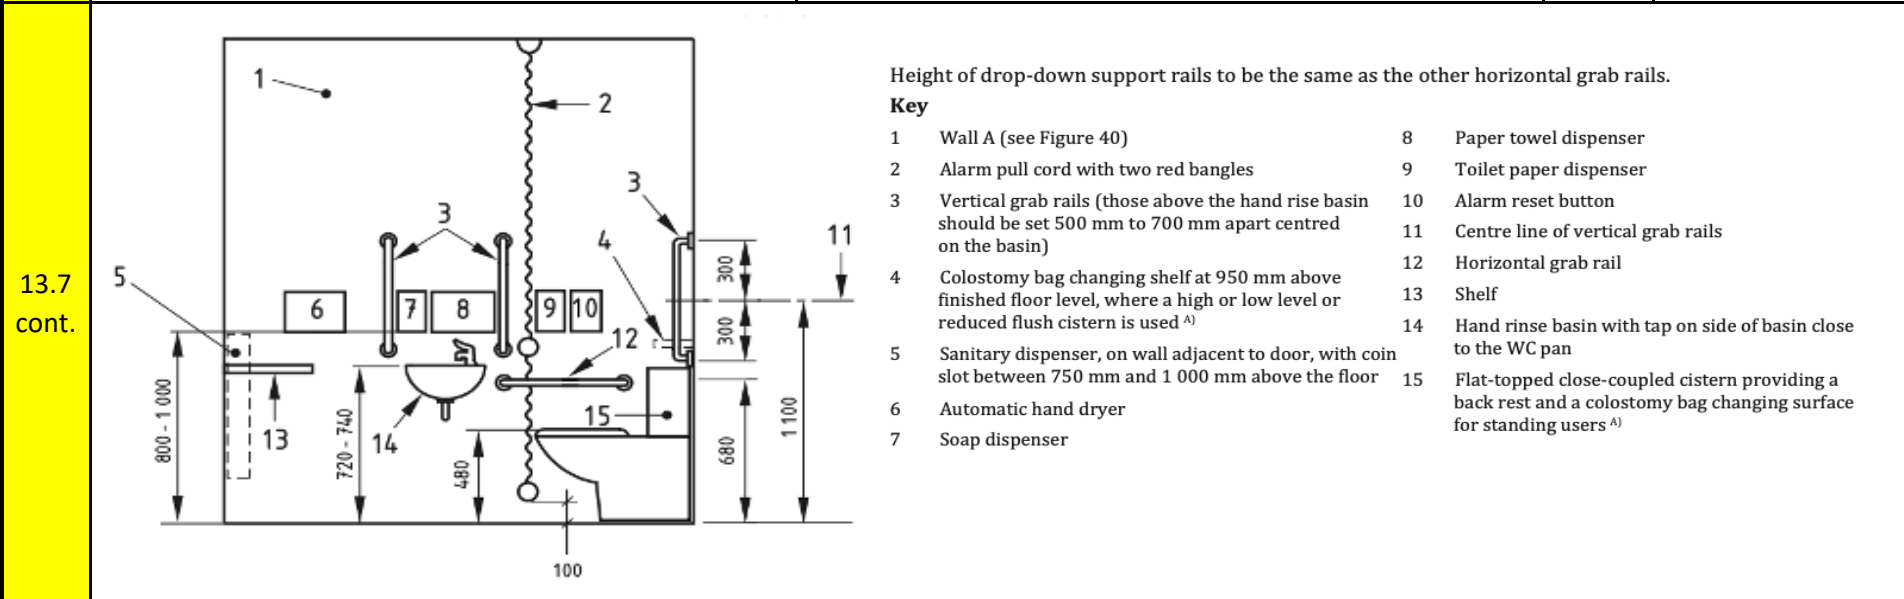
<p>13.7</p>	<p>Compartment 270 (the hygiene room) featured grab rails with minimal colour contrast, and a grab rail was missing to the left of the hand wash basin.</p> <p>A grab rail was missing to the left of the hand wash basin in the facility by years 5 and 6.</p> <p>The facility being refurbished featured grab rails that were not well contrasted to the top half.</p>	<p>The grab rail sets should be replaced with a new BS8300 compliant set that offers colour contrast. Alternatively, a contrasted background could be provided.</p> <p>A difference in LRV (Light Reflectance Value) between rail and background of 30 points is considered reasonable. In accessible WCs a blue rail set on white walls is a common accessible combination.</p> <p>Grab rails should be positioned as shown in BS8300 Figure 42:</p>	<p>M</p>	
-------------	--	---	----------	--
