Heaton Primary Accessibility Action Plan April 2023

4.1 - ACTION TABLE

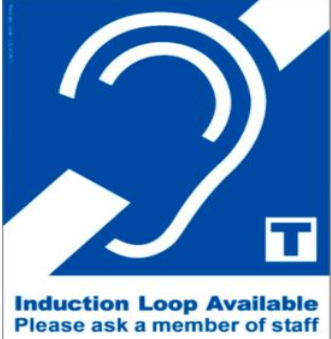
<p>6.5</p>	<p>An induction loop system was not identified at the reception area, which could assist people who have hearing loss.</p>

<p>The image shows a blue square sign with a white ear icon and a white T symbol. Below the icon, the text reads "Induction Loop Available" and "Please ask a member of staff".</p>	<p>Install an induction loop to the reception desk. Install signage indicating the availability of the facility and ensure that staff members are aware of how to use the system.</p> <p>Direct Access has its own bespoke desk induction loop for people with hearing impairments. We are able to supply, install and provide brief training. Please see here and contact us for more information - https://directaccessgp.co.uk/induction-loops-and-hearingenhancement-systems/</p> <p>BS8300 - A hearing enhancement system, using induction loop, infrared or radio transmission, should be installed at service or reception counters where the background noise level is high.</p>	<p>M</p>	<p>Portable system available.</p>

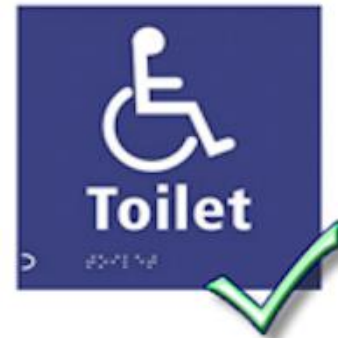
The signage on facility 42 was slightly damaged.

All accessible WC door signage should ideally be accessible to all disabled people with Braille and embossed lettering preferred.

Raised lettering / Braille Toilet signs added to 3 doors 263,270 & 171
