Heaton Primary Accessibility Action Plan

4.1 Action Table						
COSTS – N = NONE		M= MINIMAL	OG = ONGOING MAINTENANCE	ST = STRUCTURAL CHANGE	EX = MAJOR STRUCTUARL CHANGE	
Item Ref.	Details/Issue	Recommendation			Est Cost	Action Taken
PRIORITY A						
2.3	The position of the bays would not allow both bays to be used at the same time	<p>The bays should be repositioned, parallel to one another, to allow both bays to be accessed at all times .</p> <p>The designated accessible parking should be clearly marked out at least 2.4m wide x 4.8m long, plus a side transfer zone at the side and end of the bay.</p>

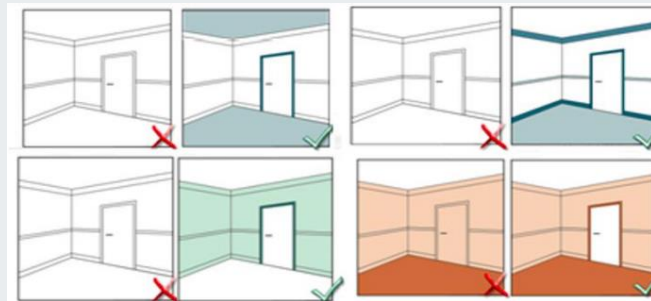
Ideally all doors should have contrast against the surroundings upon which they are seen. This could be achieved by painting the door frames a contrasting colour. Adding colour contrast will aid people with impaired vision.
